Manhole Inspection Summary

Manhole # S65G__014MH

Insp Date: **3/14/08 9:55 AM**

Location Address: **428 El Rino St.**

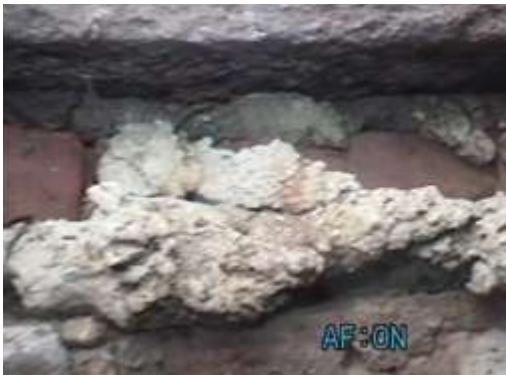
Defect 1

Condition: ☐ Sound ☐ Cracked ☐ Root Intrusion ☒ **Loose Brick** ☒ **Deteriorated**

Loose bricks deterioration in chimney at frame seal.

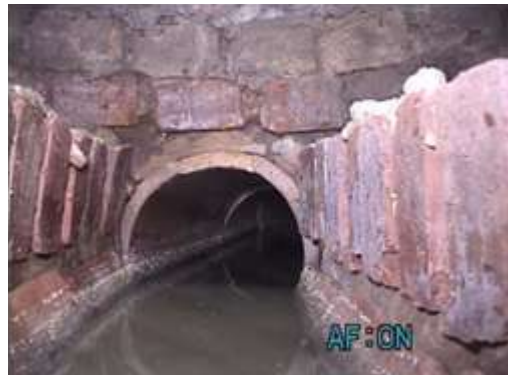
Defect 3

Crack longitudinal at 2:00 on incoming 6 O'Clock.

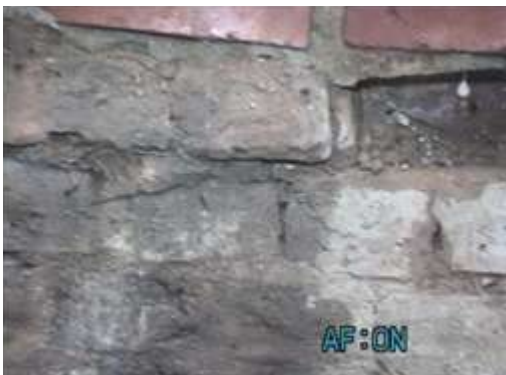
Defect 2

Missing brick in chimney.

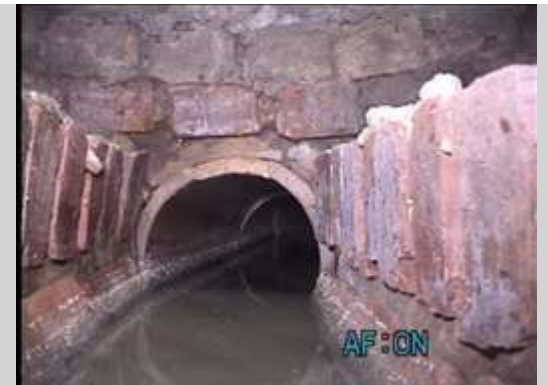
6 O'Clock Inflow

Cracks in pipe from 10 to 3.
